**Documents on Testing of Artifacts
Oak Island, Nova Scotia
Compiled by Les MacPhie, May 8, 2005**

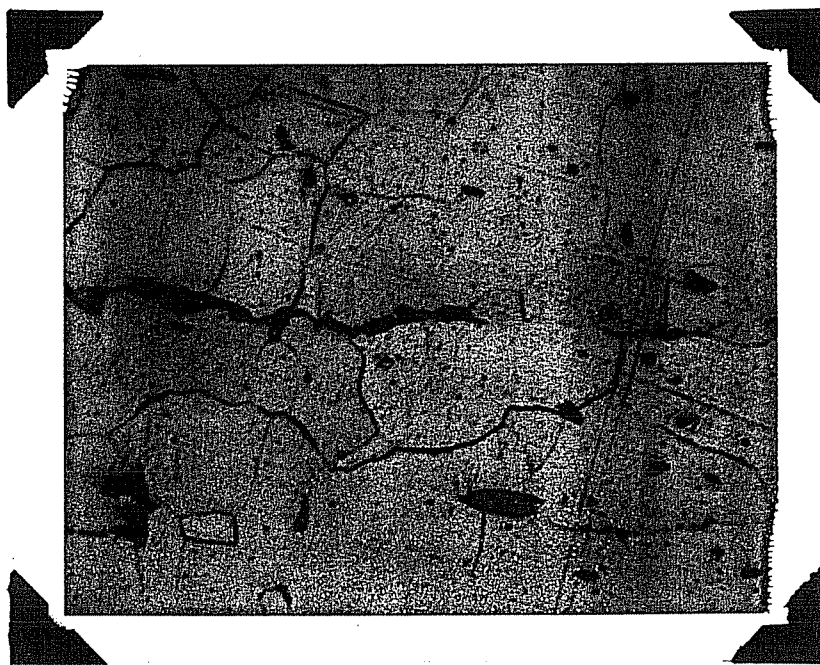
- Sample #1: "Spike found on rocks about 15 ft. opposite the dock in the wall of coffer dam. Sept. 12/70".
This sample was end-sectioned and micro-examined longitudinally. The material is puddled wrought iron, hand-forged. The absence of heat limits dating.

Sample #1 - showing slag stringers in low carbon ferritic network typical of puddled wrought iron. 330 X

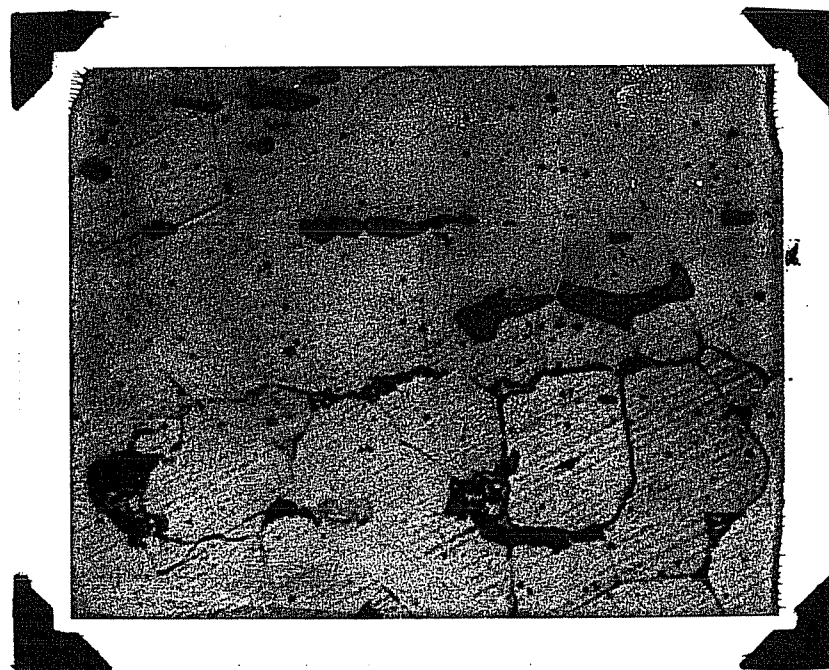
- Sample #2: "Found at West end of log in buried wooden structure - about 6' above log." Micro-examination of this round bar section shows hand-forged point on wrought iron material. No head available.

Sample #2 - showing slag and phosphide stringers in low carbon ferritic network typical of puddled wrought iron. 330 X

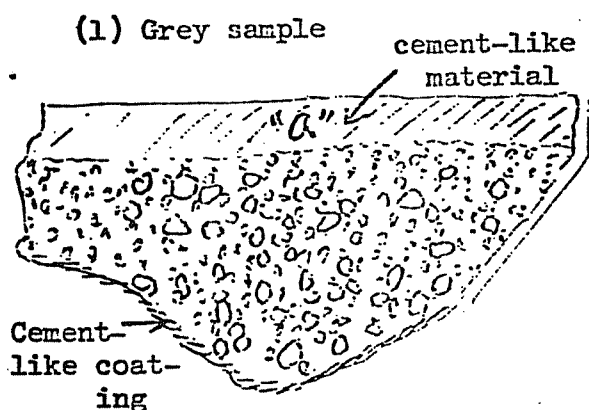
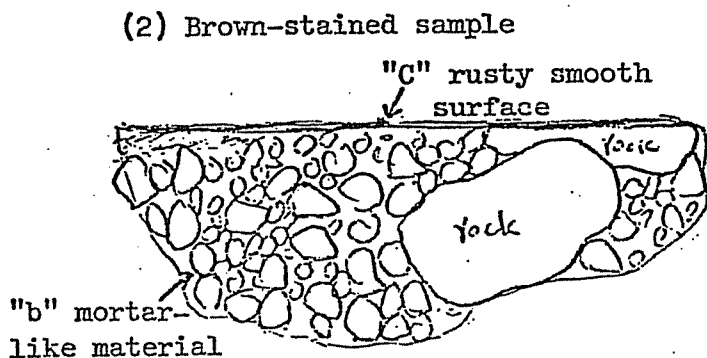
Two samples received are sketched as follows:

Sample #1 had a layer of soft material which appeared like Portland cement paste; this was designated 'Sample A'. The rest of the sample consisted of coarse sand with a matrix of the same kind of grey material.

Sample #2 contained coarser aggregate with very lean mortar-like material as matrix. The fine fraction of this 'mortar' ($\sim 45 \mu\text{m}$) was designated 'Sample B'. Most of Sample #2 was brown stained. A portion of rusty material was scrapped off the smooth surface of #2 sample and analyzed as 'Sample C'.

Subsample C was just like rust. It contained mainly amorphous Fe_2O_3 and iron hydroxide, $\text{Fe}(\text{OH})_3$. Minor compounds found were calcite, quartz, chlorite, micas, feldspar and dolomite. It appeared that the flat surface of Sample #2 had been in contact with some iron material.
