**COPY**  
TRITON ALLIANCE LIMITED  
SUBSURFACE INVESTIGATION  
THE OAK ISLAND EXPLORATION  
OAK ISLAND      NOVA SCOTIA

April, 1971.

RE: THE OAK ISLAND EXPLORATION

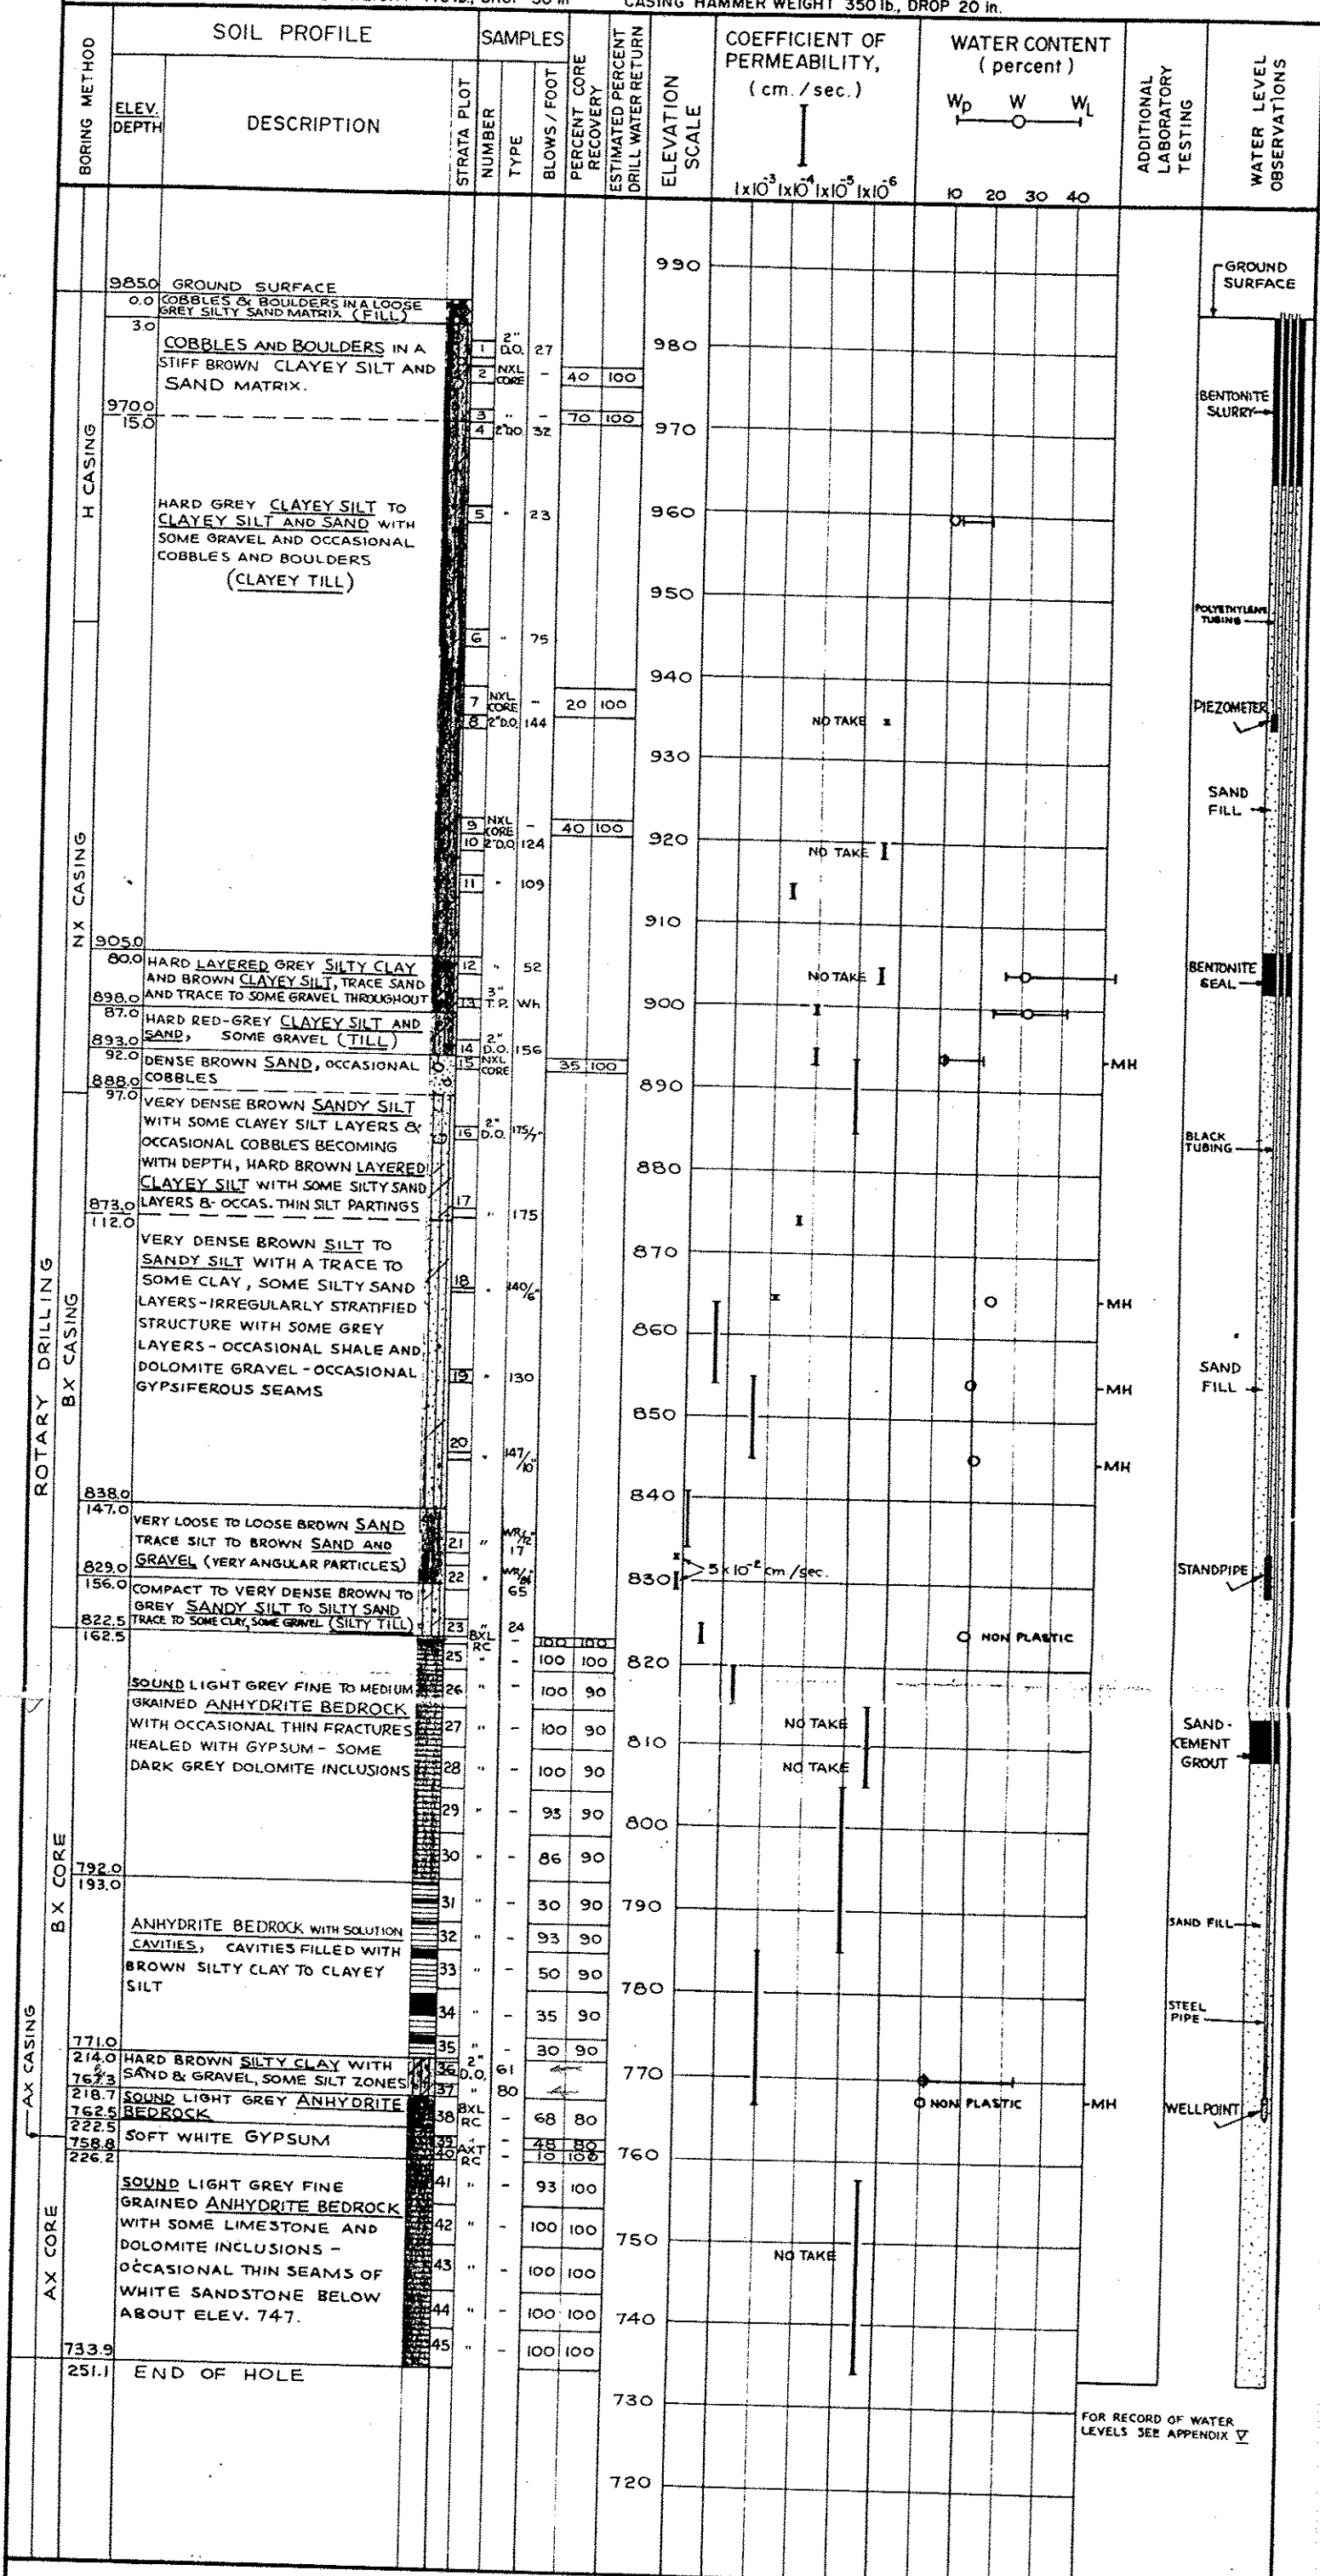
# RECORD OF BOREHOLE 102

Blue Dye: This dye was pumped into a standpipe installed in Borehole 102. The standpipe is sealed into a loose and pervious zone encountered between depths of about 147 and 156 ft. during boring operations.

- a) A 9 ft. thick zone of very loose to loose sand to sand and gravel was encountered between depths of 147 and 156 ft. in Borehole 102. The gravel fraction in this zone consists primarily of very angular sandstone.
- b) A 5-1/2 ft. thick zone of very loose sandy material was encountered within the clayey till between depths

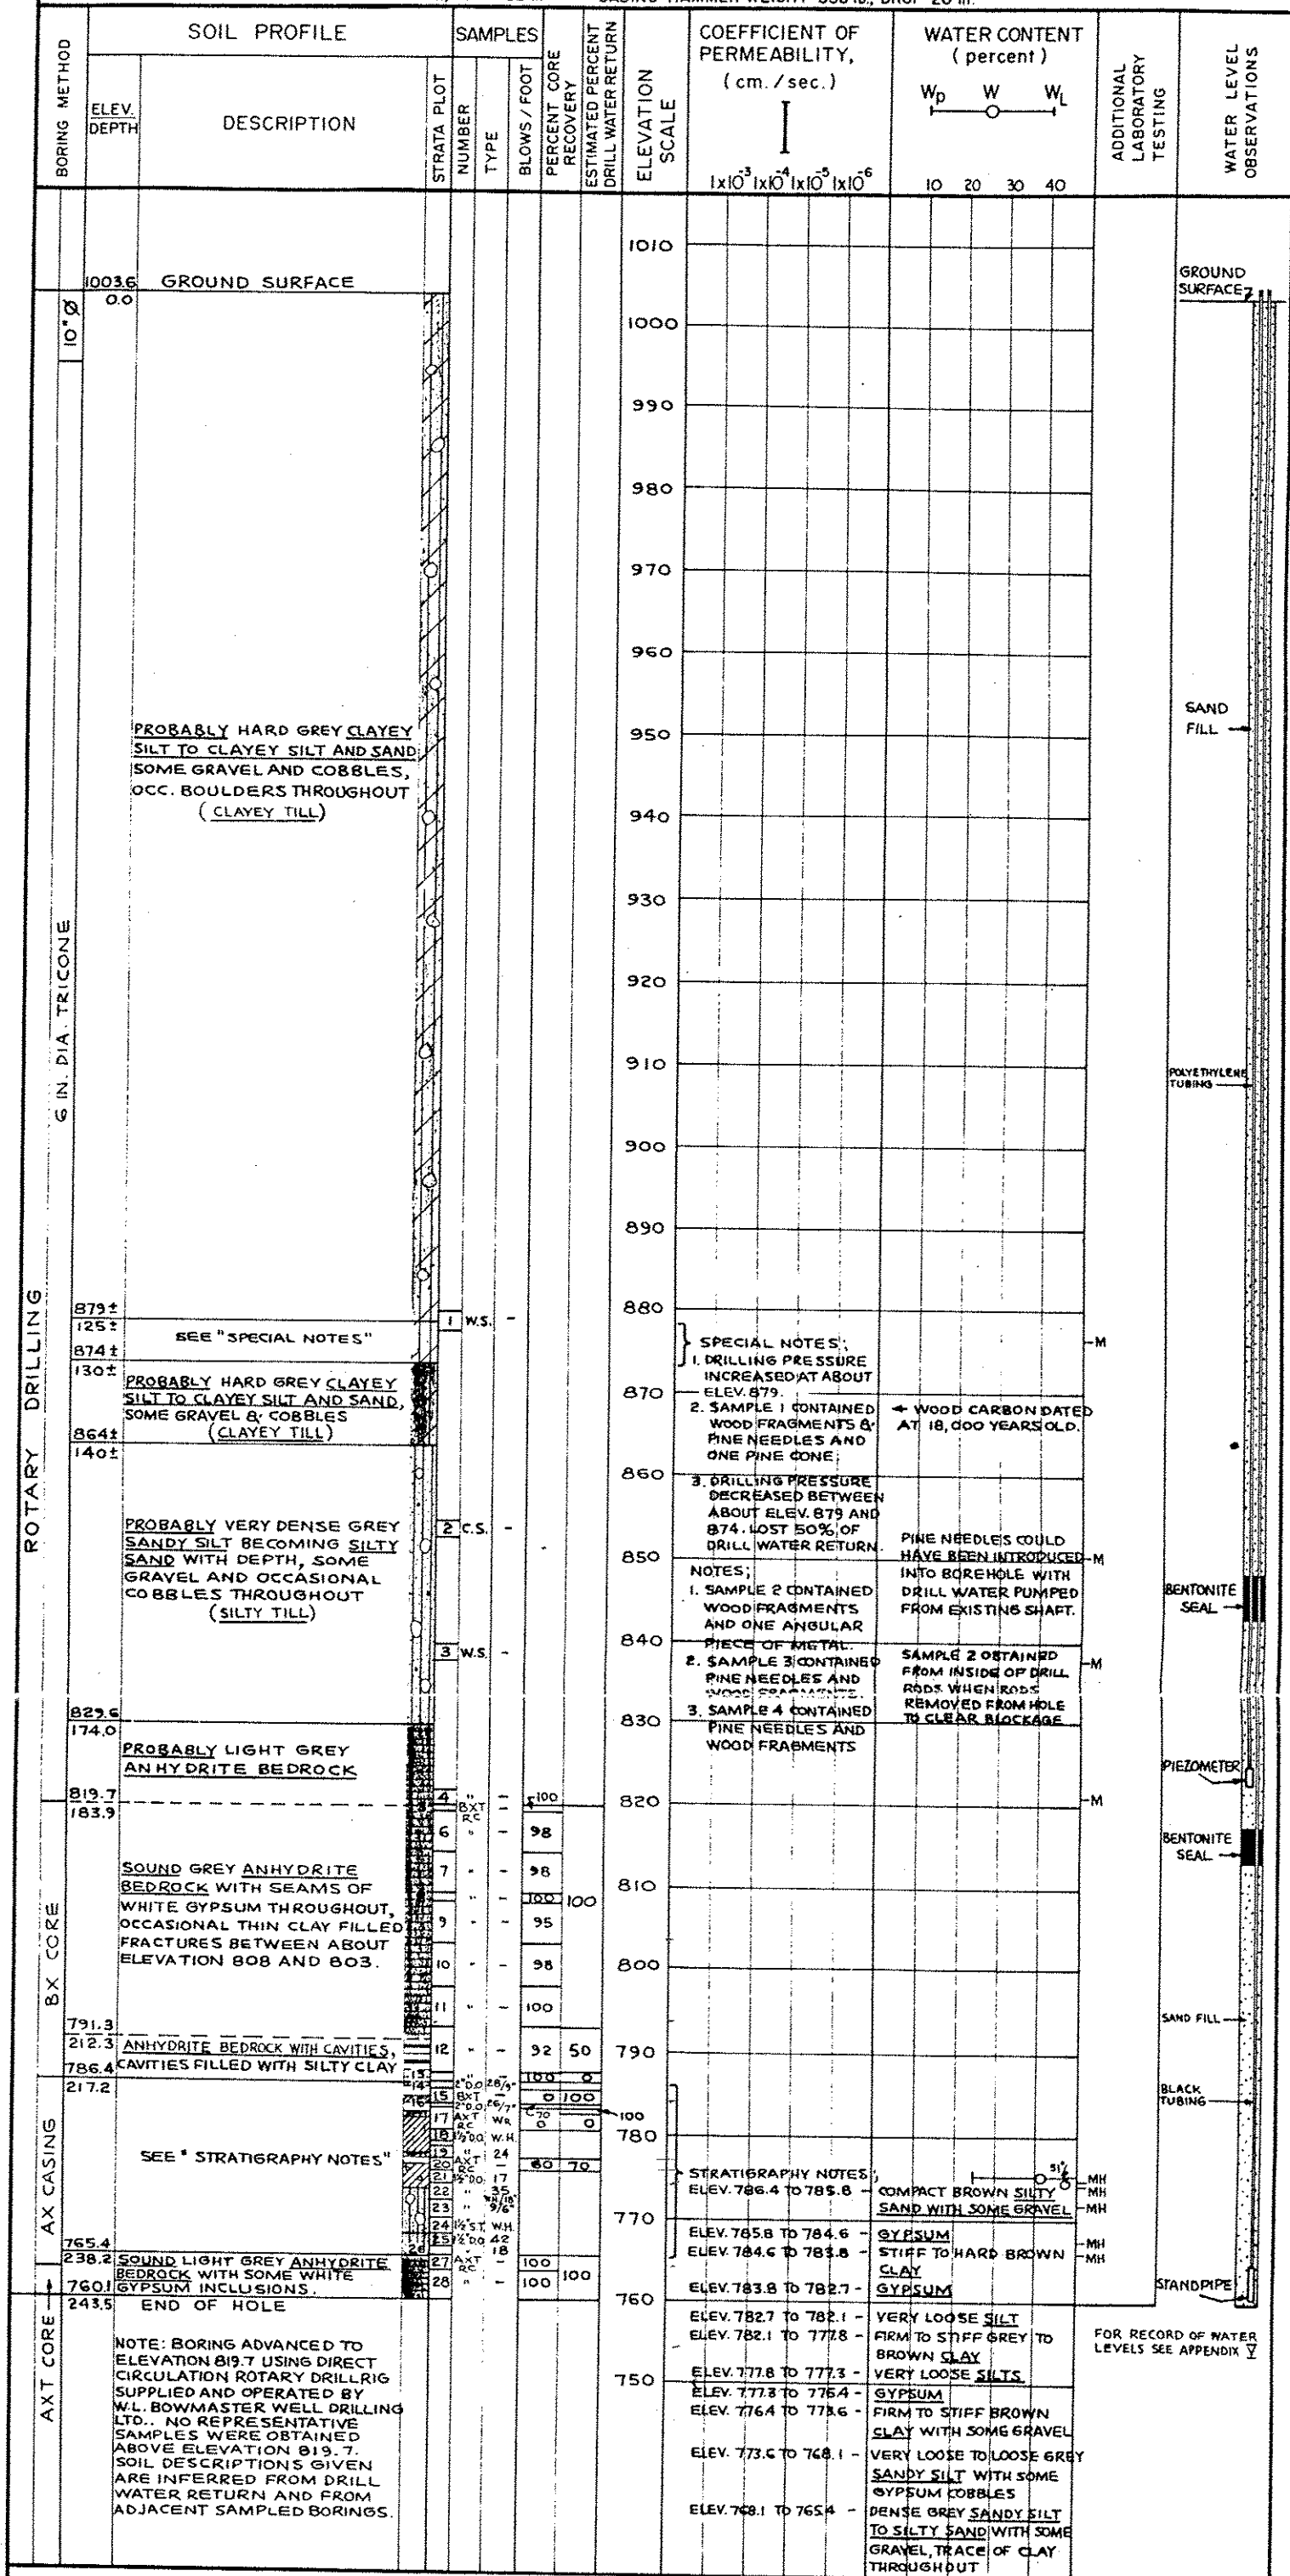
# RECORD OF BOREHOLE 202

After penetrating the obstruction at a depth of about 125 ft. the drilling pressure decreased for a depth of about 5 ft. (i.e. between depths of about 125 and 130 ft.) and in this zone approximately 50 per cent of the drillwater was lost (i.e., did not return to ground surface). This probably indicates the presence of an approximately 5 ft. thick loosened or disturbed zone.

During drilling operations between depths of about 125 ft. and 185 ft. pine needles and wood fragments were periodically observed in the drillwater return. As the hole was uncased all of these wood fragments could have come from a depth of about 125 ft. Further, the pine needles could have been introduced into the boring with the drillwater which was being pumped from a nearby partially collapsed shaft.

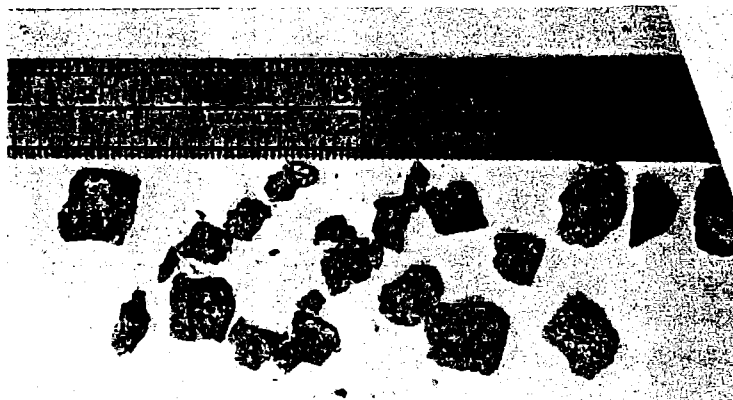
FIGURE 5

During boring operations in this hole, pine needles and wood fragments were observed in the wash water return during drilling from a depth of 84 ft. to 84.9 ft. Further, small flakes of metal were observed in sample 12 (depth of 88.6 to 89.7 ft.). It was originally thought that the pine needles and wood fragments

PHOTOGRAPH OF METAL FRAGMENTS  
BOREHOLE 201, SAMPLE 10, DEPTH 84.5 to 86.5 FT.

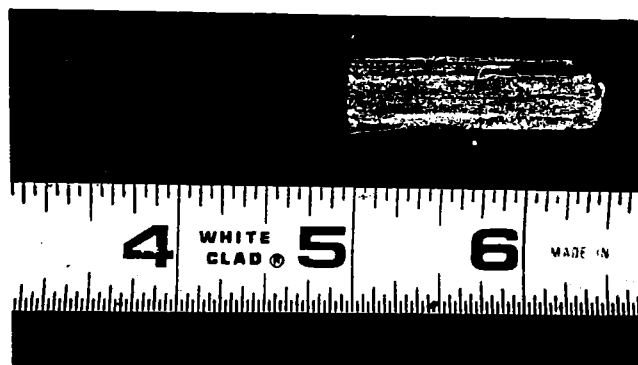
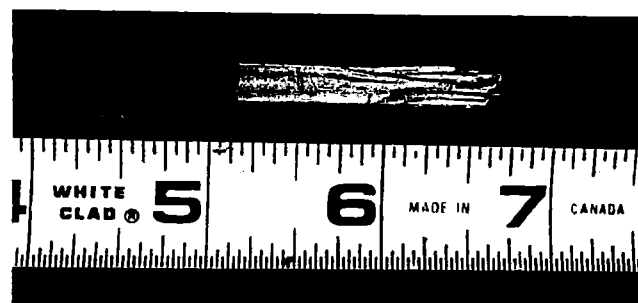
FIGURE 6

As previously noted, Borehole 202 was put down to a depth of about 185 ft. using a direct circulation rotary well drilling rig. During drilling operations an obstruction was encountered at a depth of about 125 ft. During drilling through this obstruction several small wood fragments were observed in the drillwater return. A photograph of one of these wood fragments is given on Fig. 6. One of the wood fragments was forwarded to the Faculty of Forestry, University of Toronto for identification. A copy of their report is given in Appendix III to this report. The remaining fragments were forwarded to Brock University for carbon dating. Although we have not received a copy of their report it is understood that the wood is reported to be about 18,000 years old.

PHOTOGRAPH OF WOOD SAMPLE  
BOREHOLE 202, SAMPLE 1, DEPTH 125 FT.

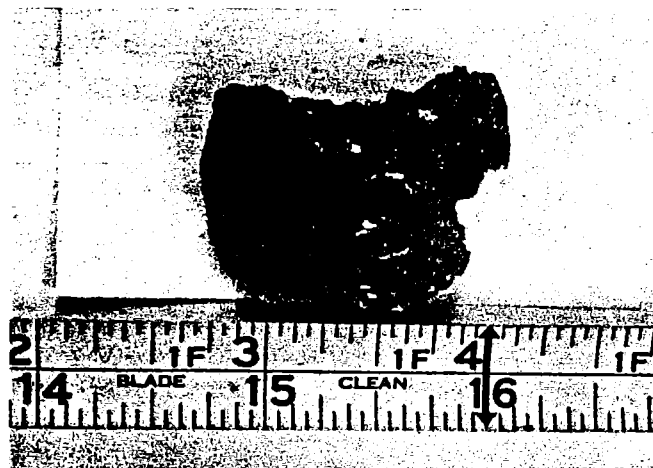
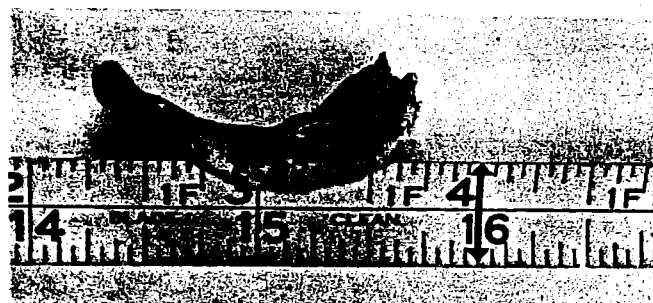
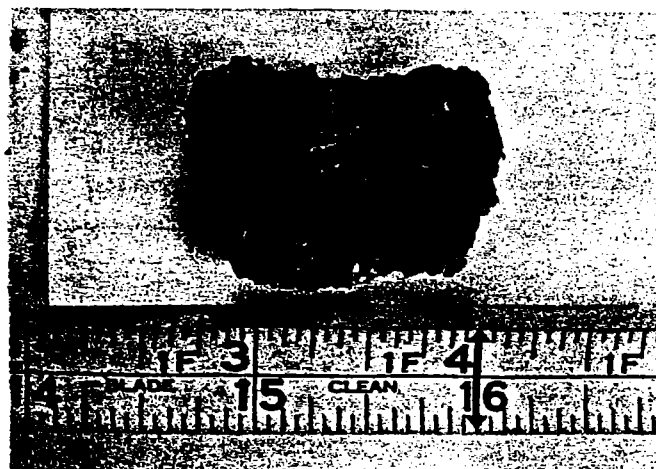
FIGURE 8

PHOTOGRAPH OF METAL FRAGMENT  
BOREHOLE 103, SAMPLE 6, DEPTH 138FT.

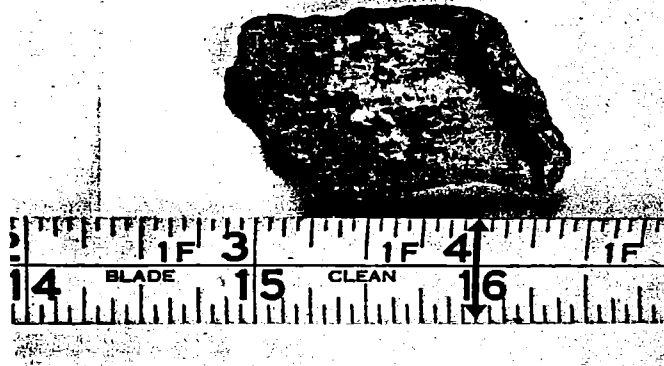
FIGURE 9

PHOTOGRAPH OF METAL FRAGMENT  
BOREHOLE 103, SAMPLE 7, DEPTH 141.5 FT.

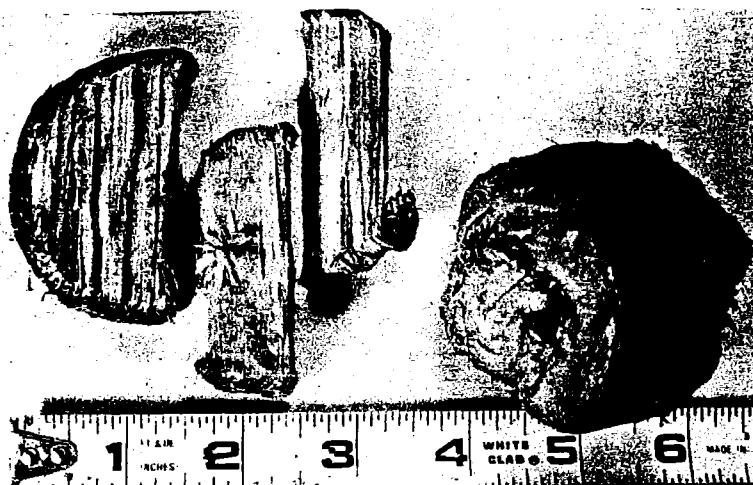
FIGURE 10

PHOTOGRAPH OF WOOD CORE  
BOREHOLE 103, SAMPLE 9, DEPTH 143.0 to 144.9FT.
