Analysis of Artifacts

Item # 163

“Spike from old wharf at northwest corner of Island”

REPORT OF NEW FINDINGS AT THE NORTH END OF OAK ISLAND

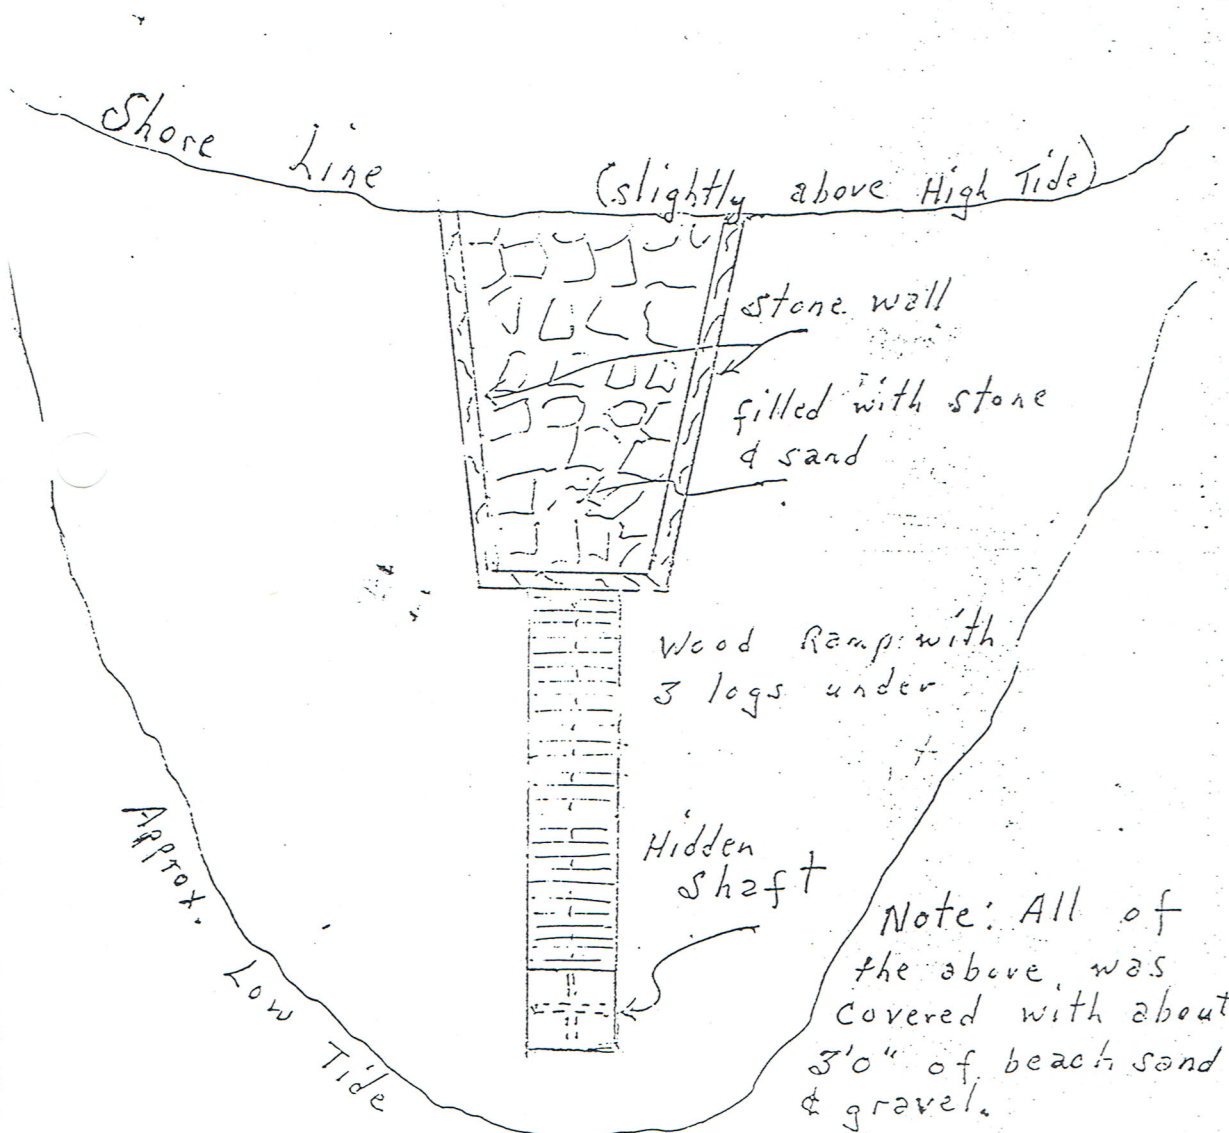
Sheet #1

Several weeks ago, in the course of digging sand and gravel to repair the causeway, a stone ramp was discovered, about 3 feet below the beach level at the north end of the island a few hundred feet north of the causeway. This ramp was made of boulders piled on long log stringers running down to the low tide level. Simple digging by hand around the ramp exposed an old spike and two pieces of metal strapping, one of which was attached to some cement-like material. There was also a lump of gravel-encrusted material which appeared to be metal. These samples were sent to Stelco and found to be very old (see attached report).

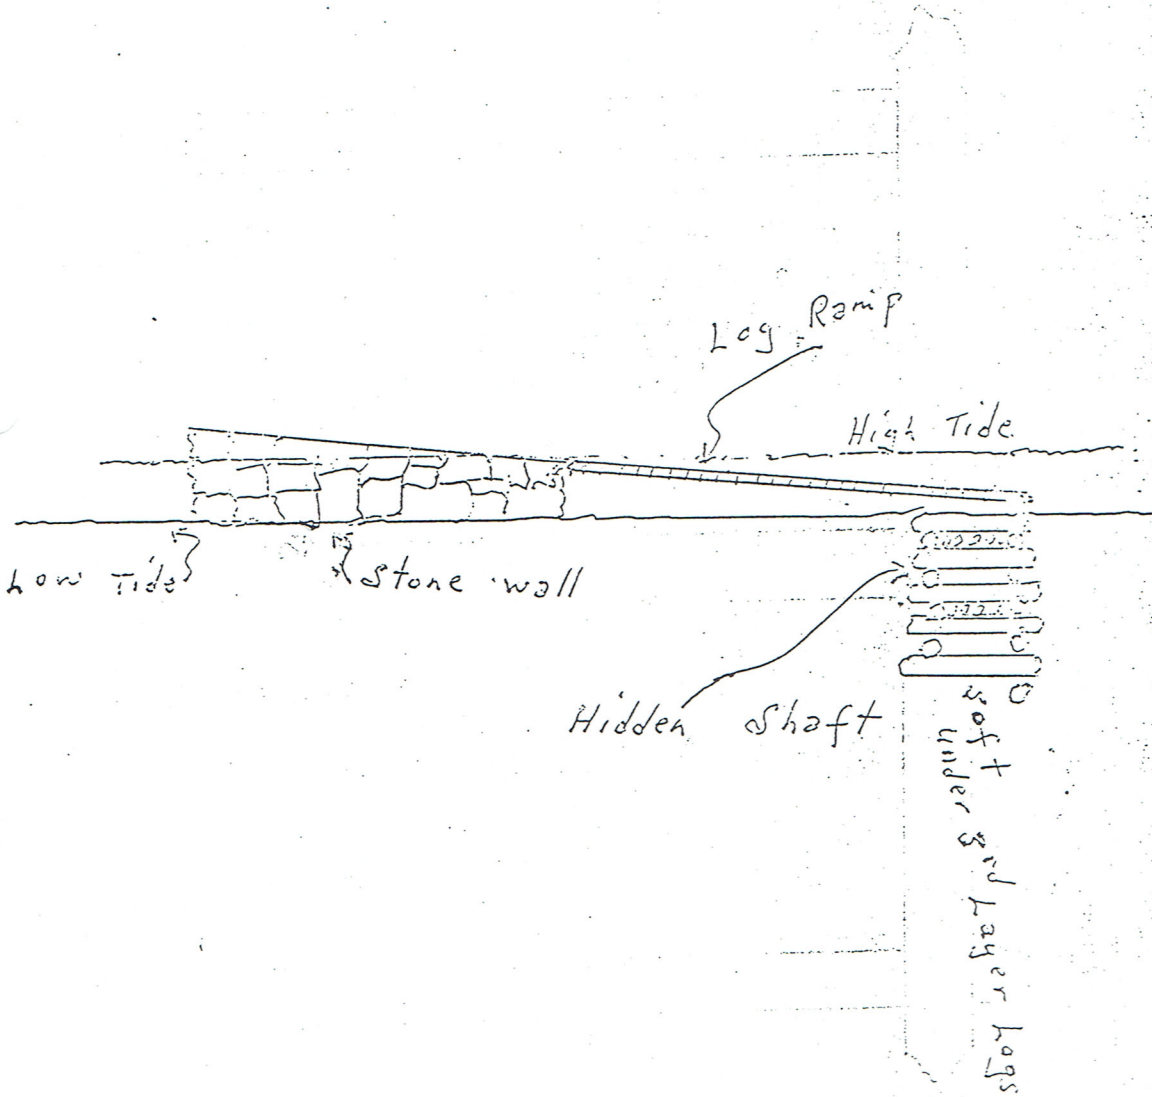
Sheet #2

Further excavation last week at the seaward end of the ramp, uncovered what appears to be a cribbed shaft (see attached drawings) divided in 4 sections by crossed logs. One of these quadrants was dug down 6 feet by hand. A loose layer of logs was found at about the 3 foot level and another tightly-spaced layer of logs was found at 6 feet. Probing below this bottom layer with a 1" pipe showed the space below to be filled with soft, soupy material and also gave indications that the cribbing extends at least 8 feet below this level.

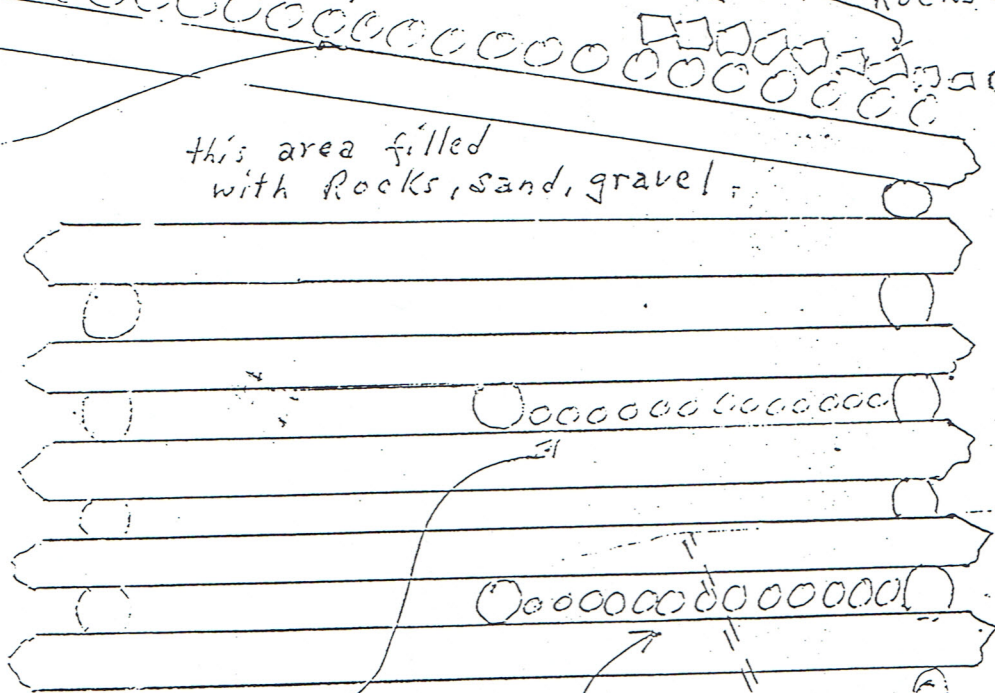
Sheet #4

- Note:
- ① Middle layer logs, loose & decayed
 - ② Bottom layer logs, tight together with layer of peat on top
 - ③ Steel pipe 10' long used for probe - hit logs 8' down

Very soupy Below logs

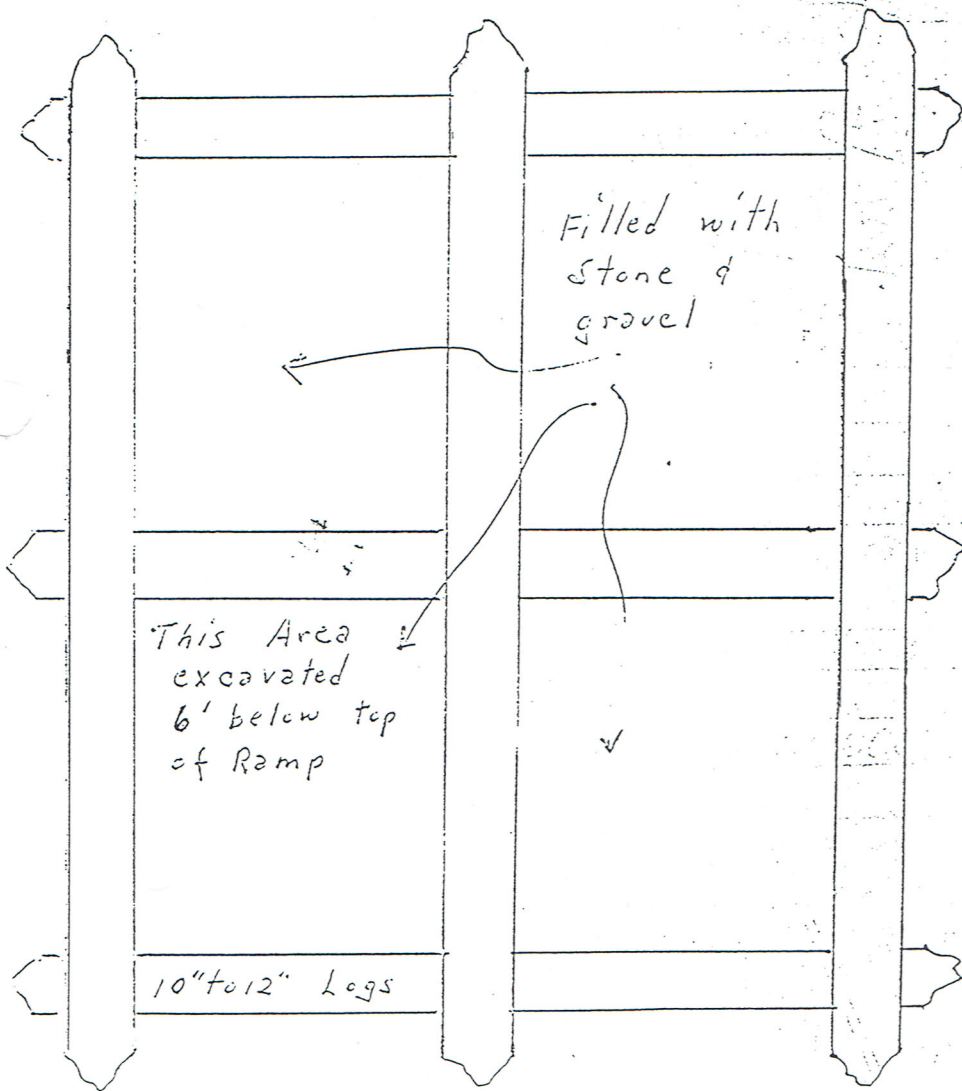
Sheet #3

A check of the surrounding sea bed shows that solid bottom is about 4 feet below the surface silts and sands. The digging and probing done to date however, shows that the shaft we have discovered extends downward to a depth of at least 14 feet and probably much further. For this reason, we believe that this is not a pier constructed by previous seafarers or farmers for a dock, since it would not have been necessary to put it deeper than 4 feet to have a permanent, solid base.
