Analysis of Artifacts

Item # 164

“Unidentified metal strap near old “wharf” at northwest corner of Island”

REPORT OF NEW FINDINGS AT THE NORTH END OF OAK ISLAND

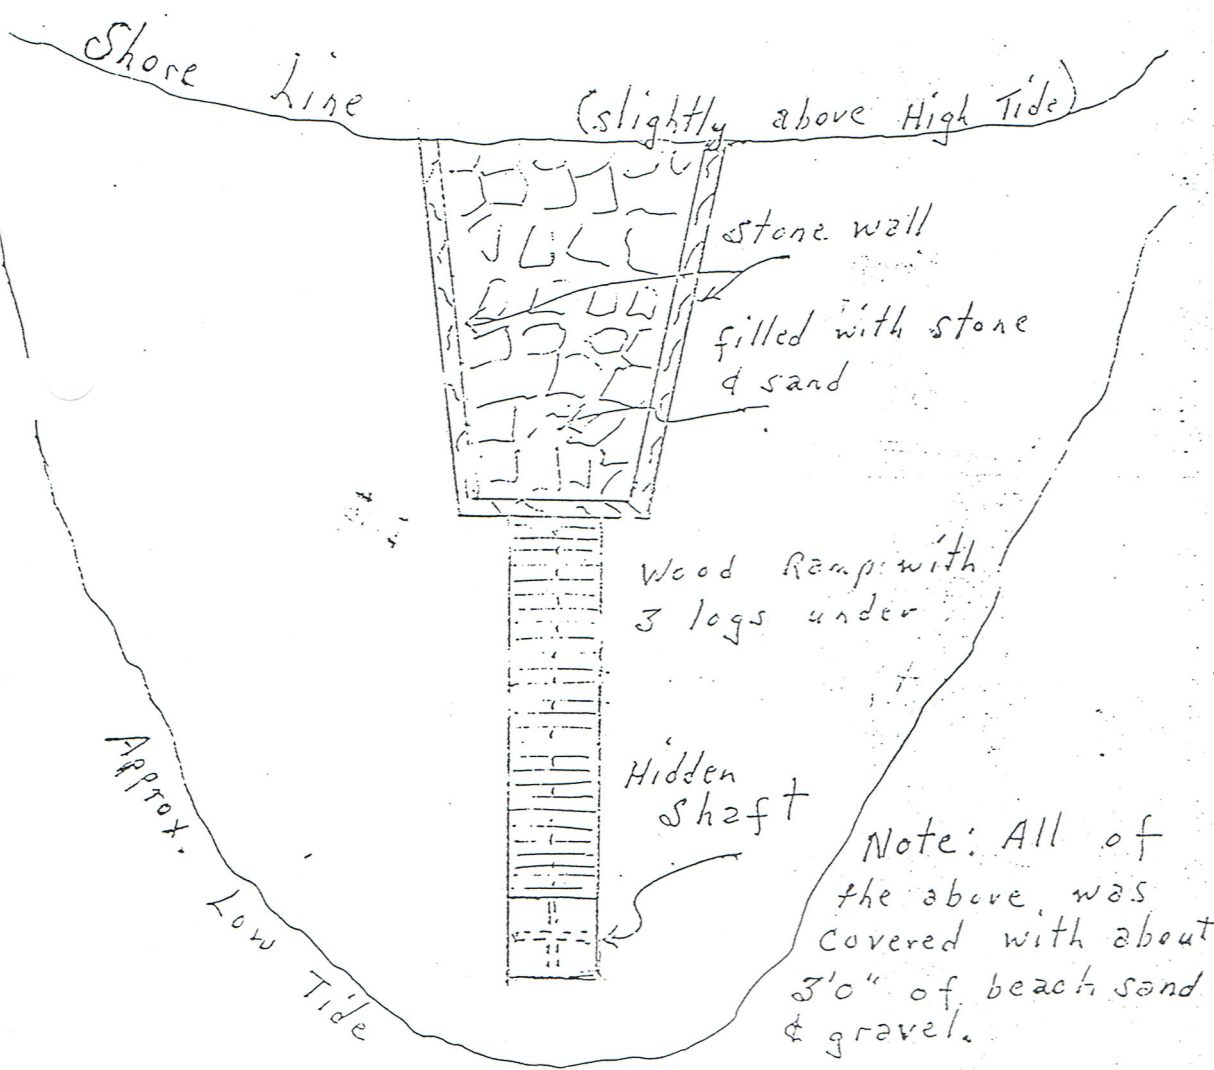
Sheet #1

Further excavation last week at the seaward end of the ramp, uncovered what appears to be a cribbed shaft (see attached drawings) divided in 4 sections by crossed logs. One of these quadrants was dug down 6 feet by hand. A loose layer of logs was found at about the 3 foot level and another tightly-spaced layer of logs was found at 6 feet. Probing below this bottom layer with a 1" pipe showed the space below to be filled with soft, soupy material and also gave indications that the cribbing extends at least 8 feet below this level.

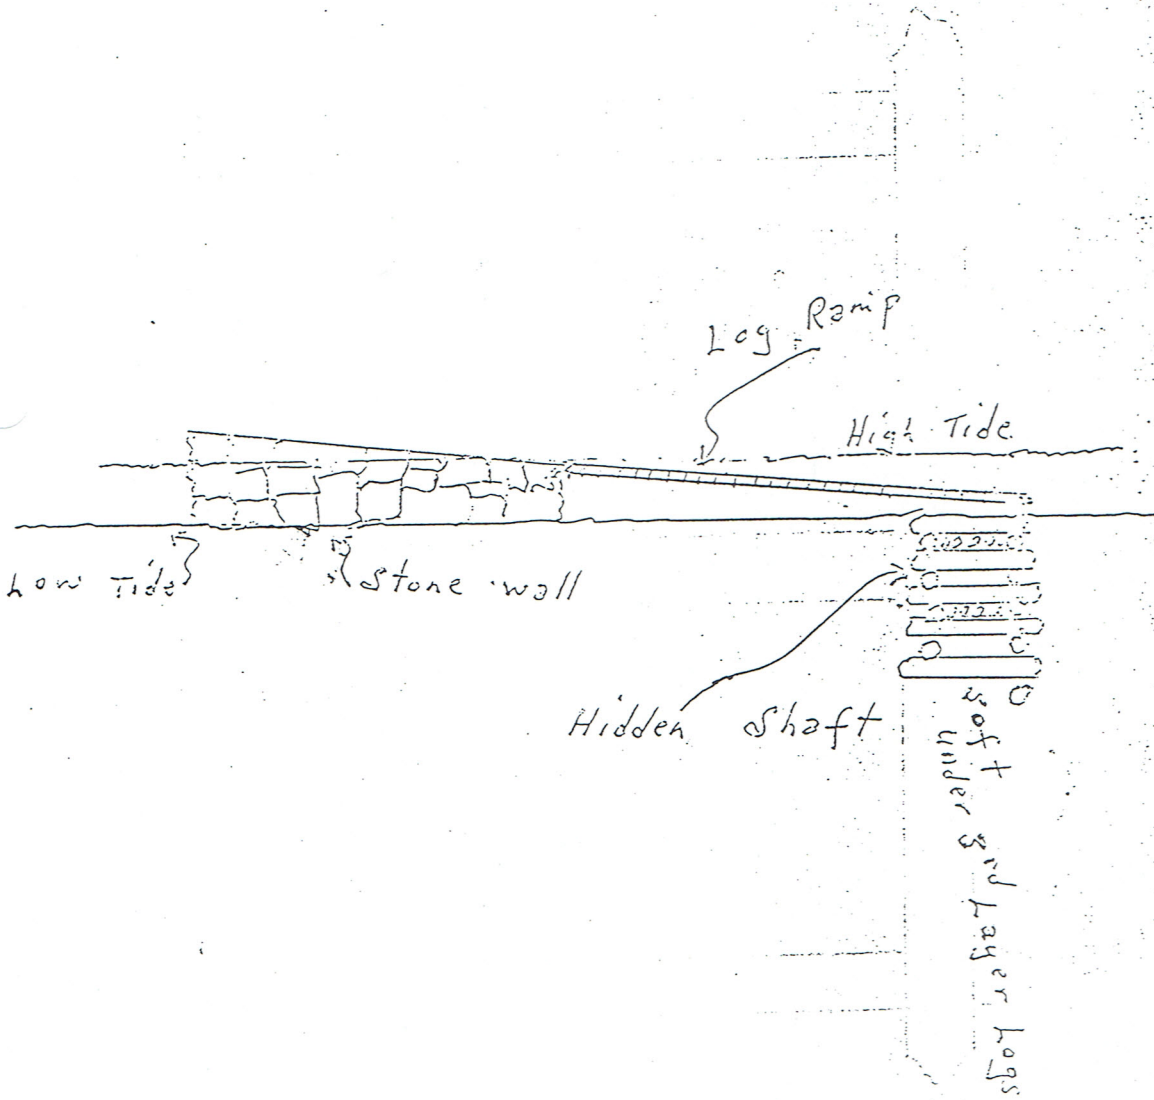
Sheet #2

A check of the surrounding sea bed shows that solid bottom is about 4 feet below the surface silts and sands. The digging and probing done to date however, shows that the shaft we have discovered extends downward to a depth of at least 14 feet and probably much further. For this reason, we believe that this is not a pier constructed by previous searchers or farmers for a dock, since it would not have been necessary to put it deeper than 4 feet to have a permanent, solid base.
